Flash Flooding

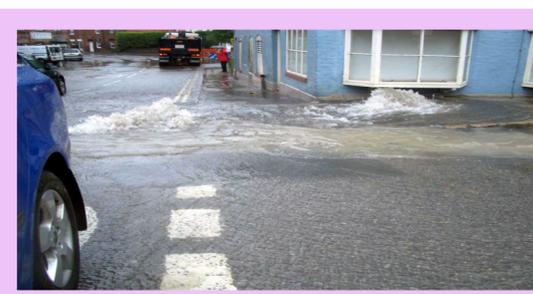
Drains may become inundated by large amounts of water in a relatively short period of time and simply not have the design capacity to cope.

Roadside gullies are designed to keep the carriageway free from surface water but can become covered with leaves and litter, limiting the drains ability to take in water.

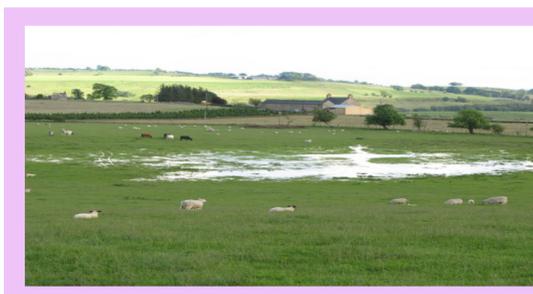
Ground Conditions

When lawns and fields have been dry for long periods of time the ground becomes hard and surface water runs over land, contributing to flash flooding. Conversely if the ground is saturated from previous wet weather it may be unable to absorb any more water, leading to large amounts of surface water runoff.

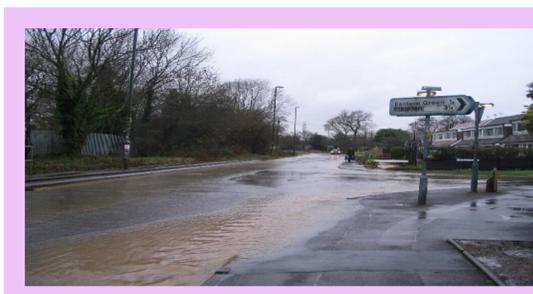
Topography

A large area may receive the same amount of rainfall but only flood in one place as the water will collect and drain to a common outlet. How the land lies will dictate where the water goes.
