Coastal Flood Defences - Groynes

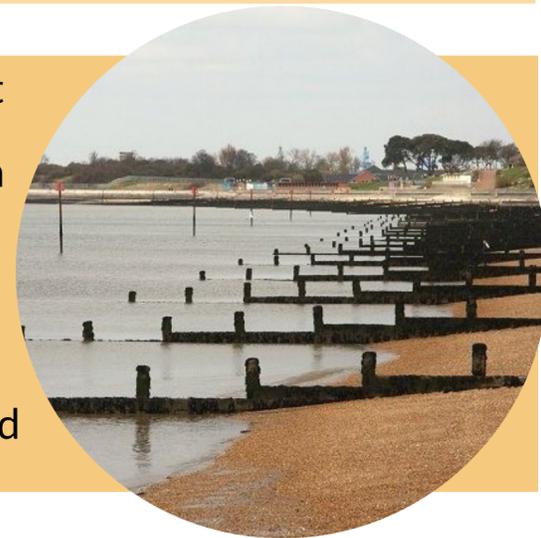
Groynes are low lying wood or concrete structures which are situated out to sea from the shore. They are designed to trap sediment, dissipate wave energy and restrict the transfer of sediment away from the beach through long shore drift. Longshore drift is caused when prevailing winds blow waves across the shore at an angle which carries sediment along the beach. Groynes prevent this process and therefore, slow the process of erosion at the shore. They can also be permeable or impermeable, permeable groynes allow some sediment to pass through and some longshore drift to take place. However, impermeable groynes are solid and prevent the transfer of any sediment.

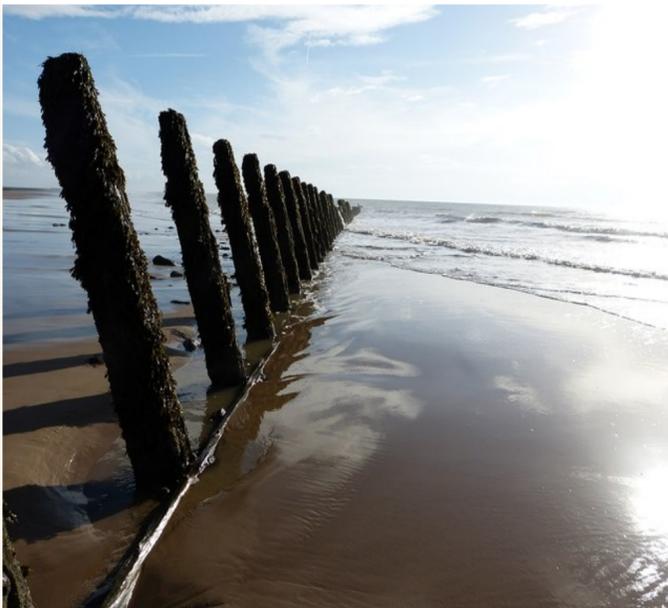
Case Study: Walney Island, Cumbria

Walney Island is a narrow island off the west coast of England, which forms a part of Barrow-in-Furness. The island is home to 13,000 residents and is approximately 11 miles in length and covers 5 square miles. The island is relatively narrow at points, with the narrowest section being 250 metres wide. The west coast of the island is exposed to the Irish Sea and the east coast has many low lying wet marshlands. Exposure to high tides and storm surges has caused progressive coastal erosion over time as well as extreme flood events. Often, these flood events have been capable of breaching the narrowest parts of the island, separating the south of the island from the north and at times, this has cut off access to more rural communities and businesses. In order to reduce the flood risk and limit the amount of coastal erosion, wooden groynes have been built along the coastline. It is hoped that these defences will also prevent the island being divided during high tides.
